### CASE STUDY

# TRENCHLESS CULVERT REHABILITATION, CITY OF BRANTFORD

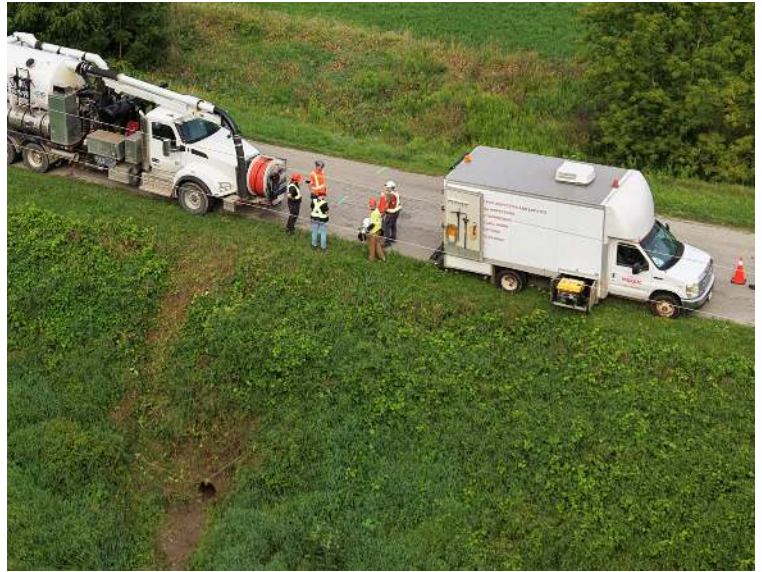
A corrugated steel stormwater pipe ran 20 feet beneath Oxbow Road, a dead-end road serving a small community at its end. The culvert had corroded over years of service and was beginning to sag at the midpoint, putting it at risk of collapse.

Wessuc lined the existing culvert in place with a thermoformed PVC-A liner, a trenchless system that rebuilds the pipe from the inside. The crew completed a single 70-ft run, ditch to ditch, restoring the 15-inch line's structural integrity without excavation.

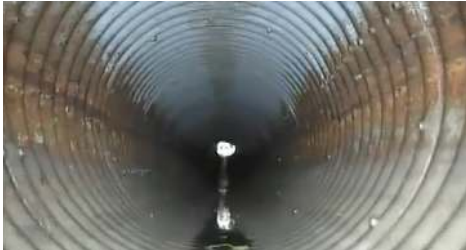
- 1. Pre-installation CCTV**  
Condition assessment and liner sizing.
