### CASE STUDY

# TRENCHLESS CULVERT REHABILITATION, CITY OF BRANTFORD

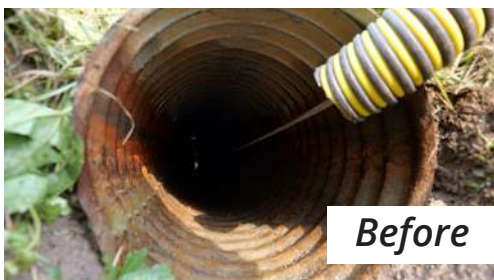
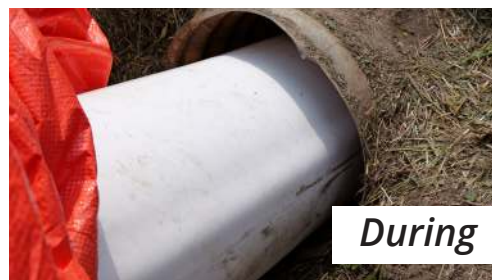
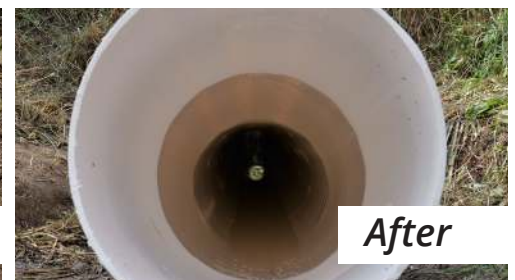
A corrugated steel stormwater pipe ran 20 feet beneath Oxbow Road, a dead-end road serving a small community at its end. The culvert had corroded over years of service and was beginning to sag at the midpoint, putting it at risk of collapse.

The install took less than a day to complete with a six-person crew - one shift, compared to a multi-week open-cut replacement. CCTV inspection was run before and after to confirm the condition of the pipe.

Wessuc lined the existing culvert in place with a thermoformed PVC-A liner, a trenchless system that rebuilds the pipe from the inside. The crew completed a single 70-ft run, ditch to ditch, restoring the 15-inch line's structural integrity without excavation.

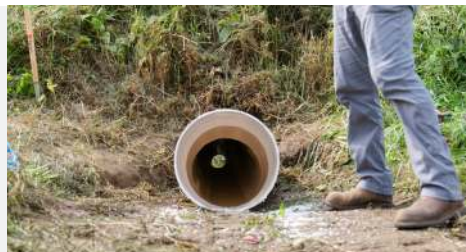
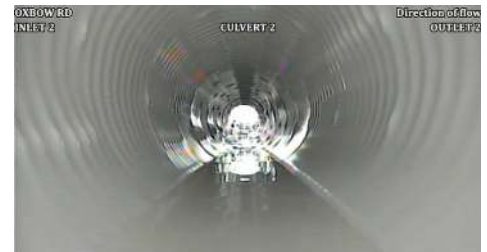
- 7. Post-lining CCTV**  
Final inspection, and delivery of reports for installed pvc lining.

- 50-year expected service life.
- No loss of community or emergency access during the work.
- Less than 1 day process versus multiple weeks for open-cut replacement.
- No excavation and no chemicals, with before-and-after CCTV verification.
